SUBARU TURBO OIL STARVATION

WARNING !

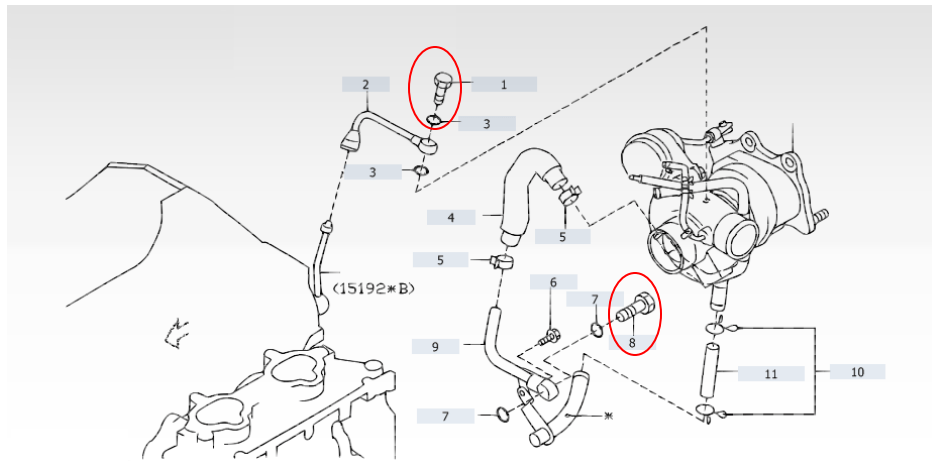
Tomioka Racing recommends REMOVING the factory ‘Turbocharger Oil Supply Mesh Screen’, located in the factory oil feed banjo bolt at the cylinder head, in all vehicles running Tomioka Turbochargers. The bearings used in these turbochargers have very little tolerance for reduced or limited oil supply. Tomioka turbochargers require approximately double the amount of oil volume compared to stock turbochargers. This is due to the fact that Tomioka turbochargers have higher volume flow requirement compared to factory turbocharger. The turbochargers can fail quickly with restricted oil supply to the turbo.
